PRELIMINARY CONDITION ASSESSMENT AND BUDGET COSTS

The Barbican Mural by Robert Lenkiewicz (1941-2002)
'Methaphysical ideas current in England during the period 1580-1620'

*The Waterfront Partnership and The Lenkiewicz Foundation,
Plymouth*

1st May 2015

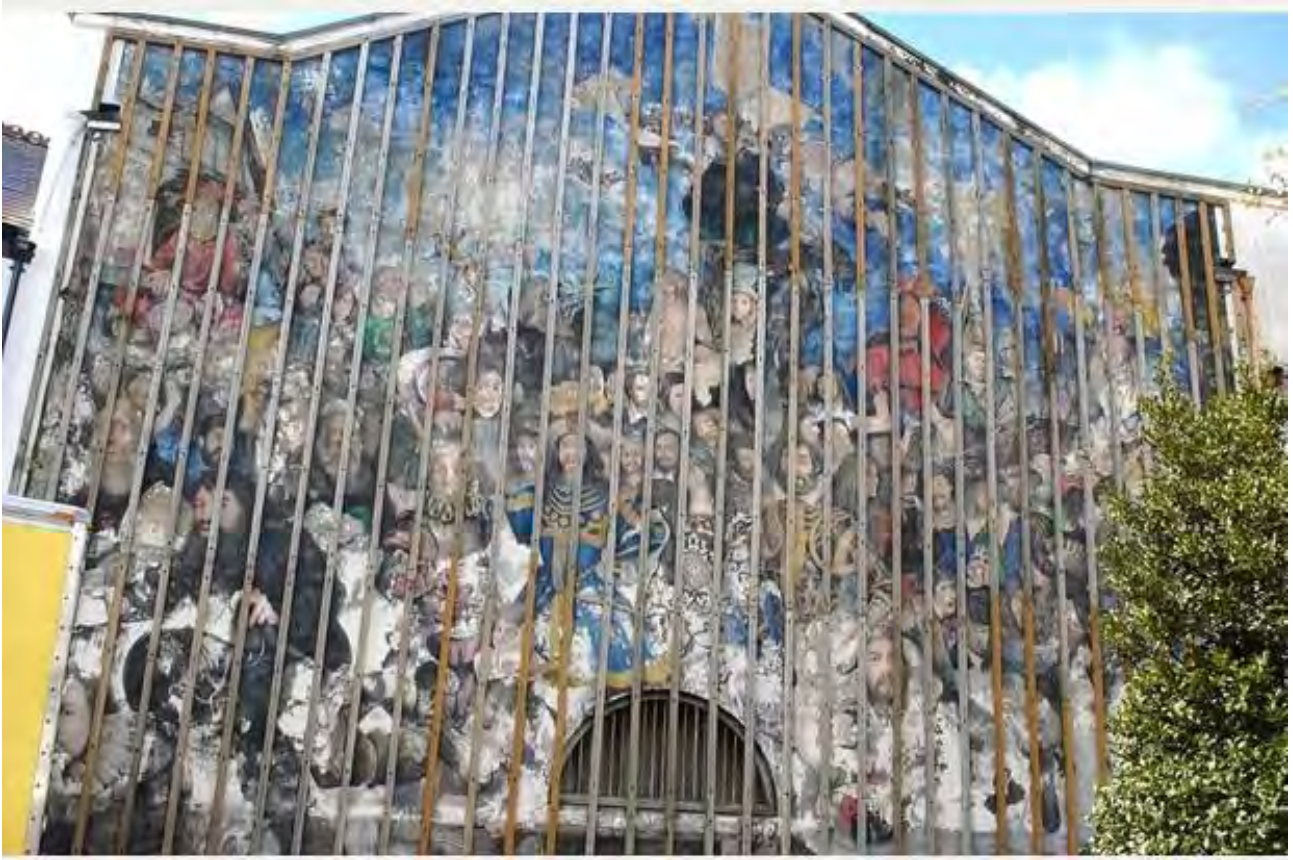
The Barbican Mural by Robert Lenkiewicz in 2014. © The Lenkiewicz Foundation.

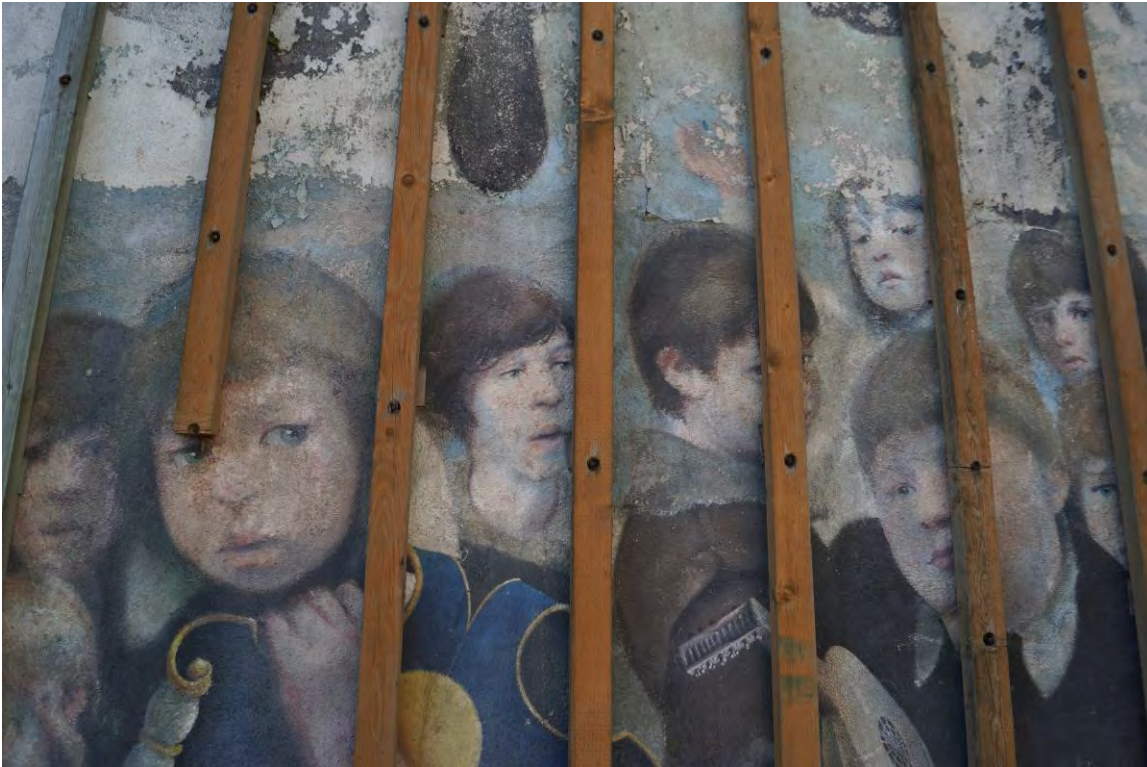
There is serious interface delamination and loss across the surface, visible as the breaking of large curled pieces. The paint is extremely vulnerable and brittle. In the lower section, however the character of the paint structure has remained intact as was easily accessible from ground level for repainting.

Lower right section of mural depicting Lenkiewicz's children. This section was repainted by the artist himself on several occasions and displays fewer instances of peeling paint.

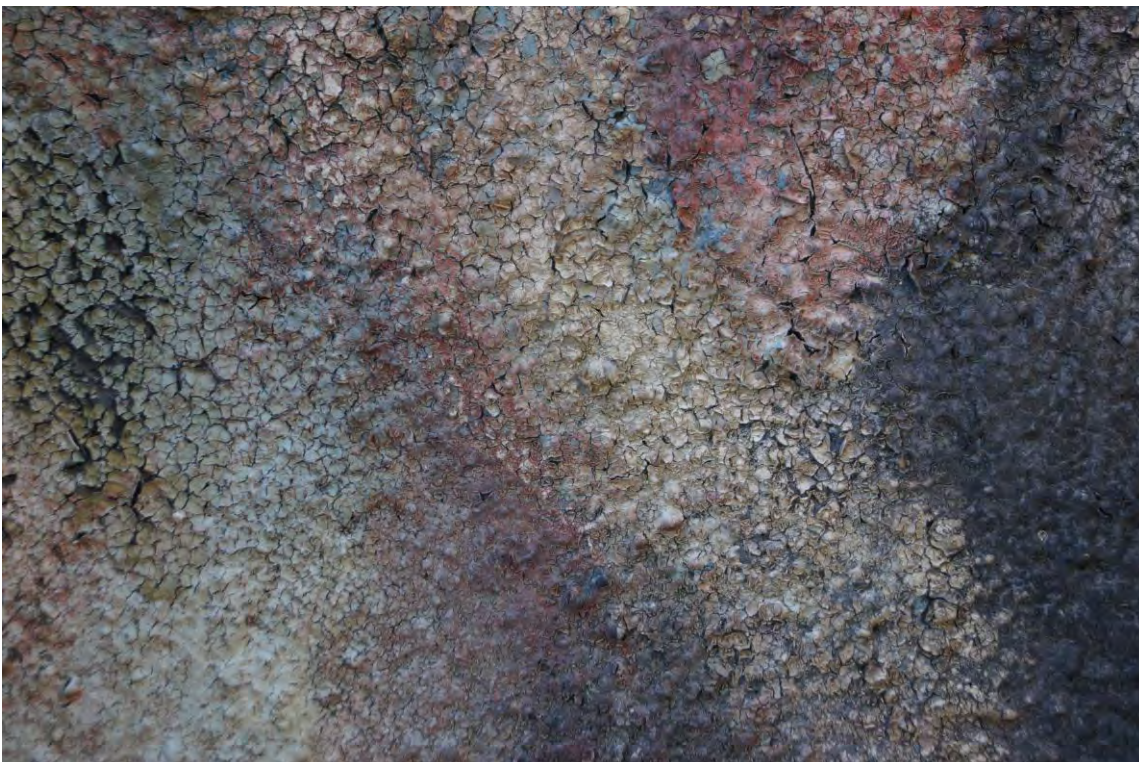
Detail showing breakdown of the paint binder – first stage of paint degradation eventually leading to cracking and loss of adhesion.

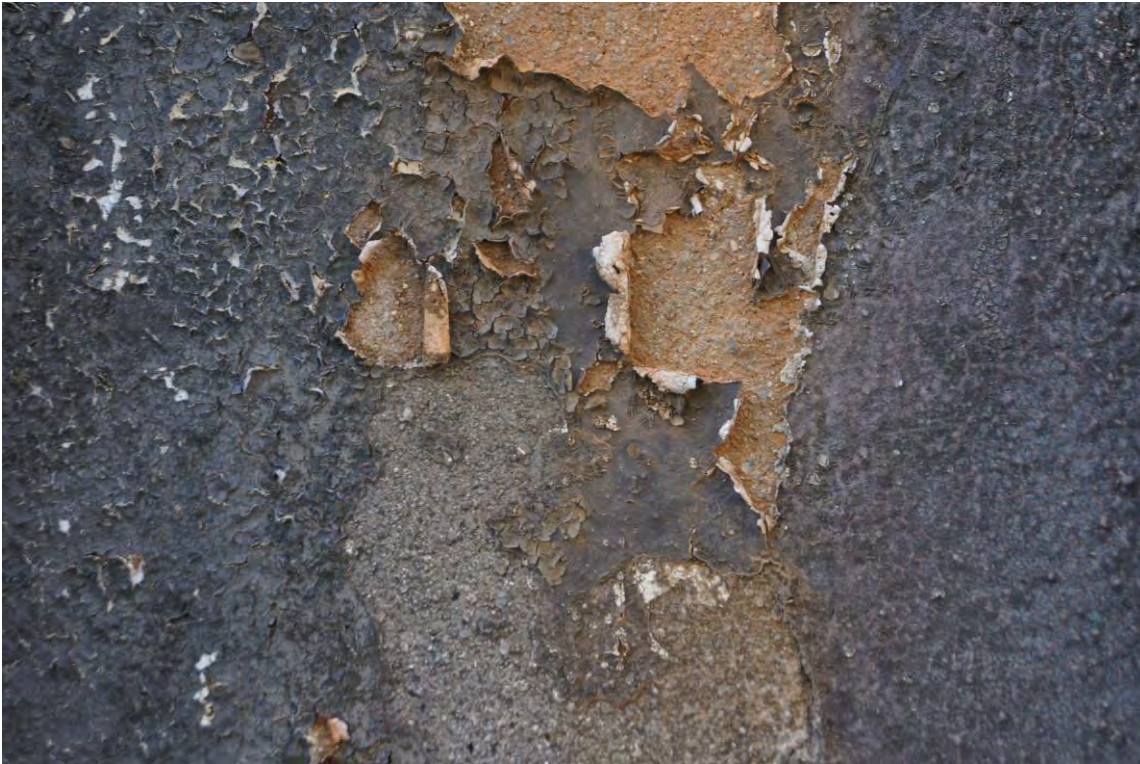
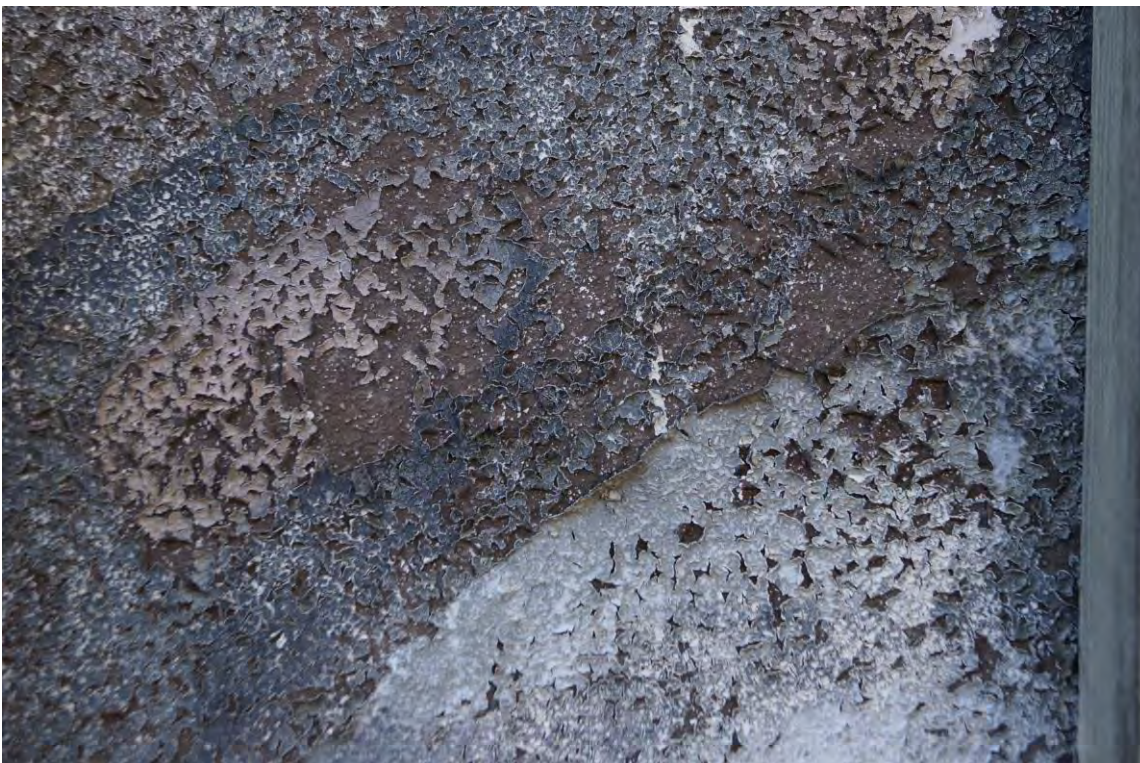
It seems that the paint layers themselves comprise a commercial house-hold paint of Dulux brand. The paint layers are generally in very poor condition. The colours have generally faded and there are multiple areas of delamination and loss of paint material, which seem to be the result of various different environmental factors:

- i. Extremes of temperature and humidity, freeze-thaw cycles and capillary rise leading to salt effluorescence, cracking and lifting of paint layers;*
- ii. Exposure to ultraviolet rays accelerating the deterioration of paint binder and causing hazing, yellowing and fading of pigments;*
- iii. Rain fall leading to salt effluorescence, cracking and lifting of paint layers, drips and stains;*
- iv. Exposure to local moist sea environment, leading to moss and lichen growth and salt deposits.*

Images showing instances of extreme weathering to paint layers. Amongst them, fading, mildew and dirt build-up, extensive paint flaking and paint loss.

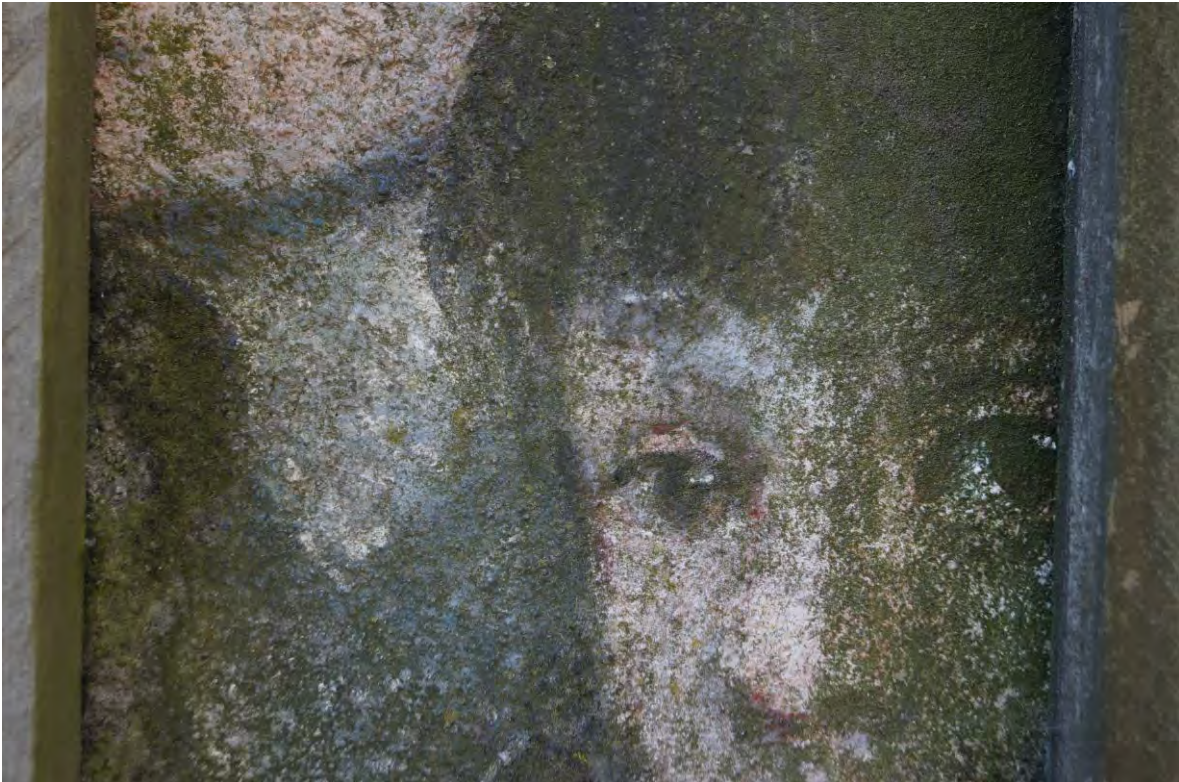
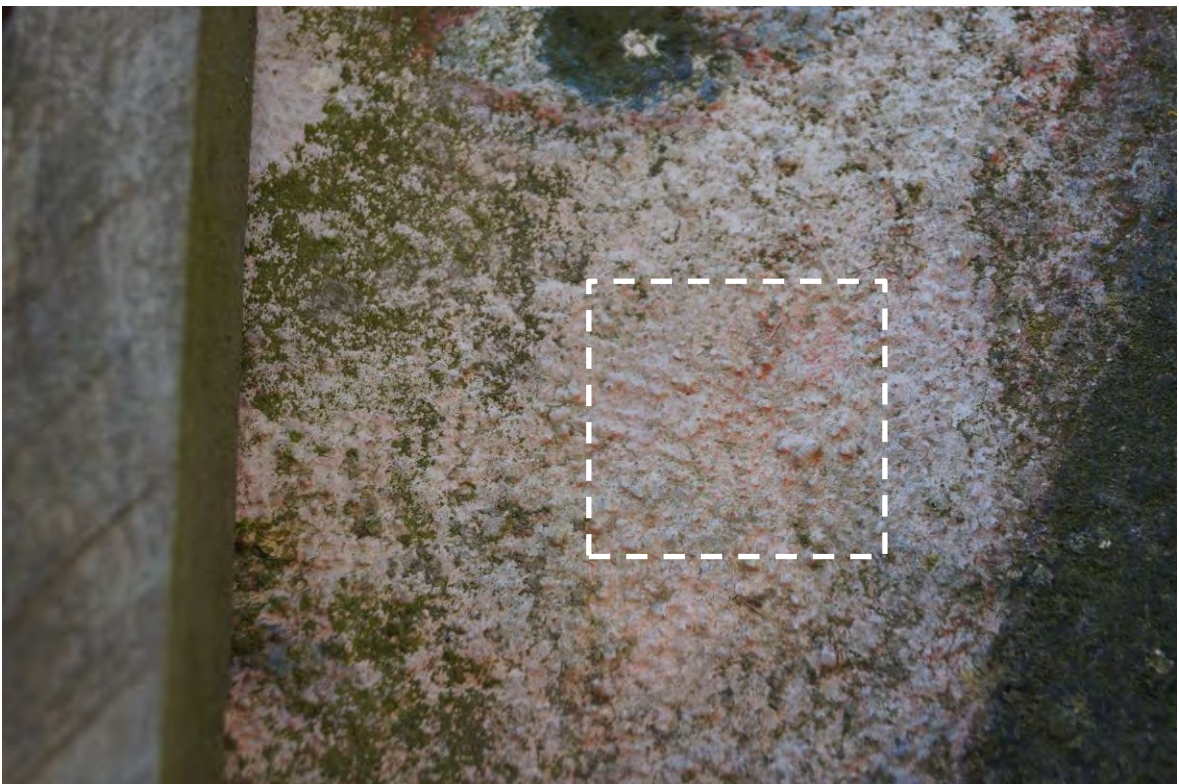
The paintings appear unvarnished. The surface is generally matte, with a patchy and dry texture. In addition to grime, debris and pollution, there is also a considerable accumulation of mildew and moss across the surface, as the painting has been exposed to a moist environment.

Images showing lichen and moss growth across the paint surface. A cleaning test was conducted to ascertain the solubility of dirt and biological growth (below).
